## Restoration Proceeds

# SAVE THE BUG

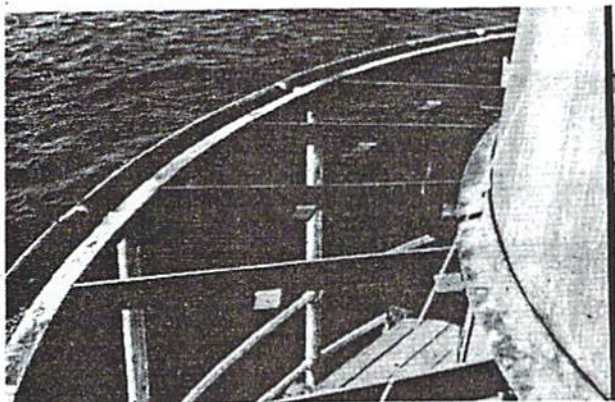
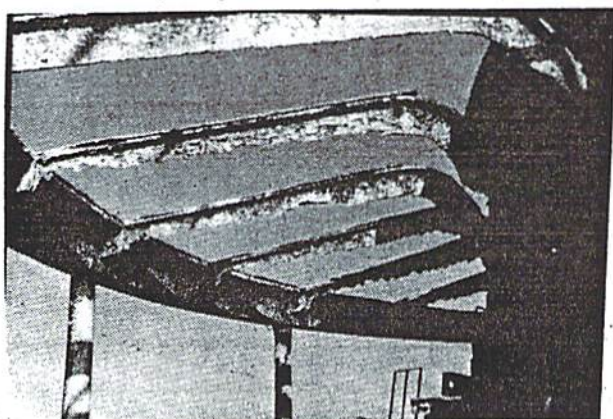
The new walkway has been installed completely around buglight. The pre-treated lumber has a guaranteed life of 30 to 50 years. A ton of old wood-work and miscellaneous structures have been removed thus restoring the structure more nearly to its original design.

Also 3 new steel doors have been fabricated and welded where necessary to secure the structure from the elements.

A new mooring device has been installed so workmen may secure their boats while working, regardless of tides or weather.

In addition, a new construction boom has been welded to the structure so that equipment -- even an electric generator -- may be readily transported from the boat or launch directly to the walkway area. The overhead chain fall is a great time saver.

The lantern area has been scraped and painted. The U.S. Coast Guard has officially given us permission to paint the light house white for better visibility in night and day. Locks and doors and hatchway have been installed for equipment protection.

All of the 32 roof supports are in bad shape. The severe rust and erosion-corrosion has taken its toll. Before the canopy roof was removed by the Coast Guard it was possible to break off pieces of the roof with the fingers; it is now necessary to remove all of the roof supports because of their weakness. Our welder, Dave Silvia, has been working from 7 am to 7 pm recently in order to burn off several supports, drill out miscellaneous pieces and install new carbon

steel roof supports. All supports have been primed in order to prevent rust. Dave is installing brackets on which to install the roof. His work will preserve the "Bug" for at least another 100 years. A newly invented protective material on the market will help to insure this projection.
